Site Characterization and Risk Assessment Report

**Formerly Used Defense Site
Nike W-92
Rockville Launch Area
Gaithersburg, Maryland**

**City of Gaithersburg
31 South Summit Avenue
Gaithersburg, Maryland 20877**

November 06, 2007

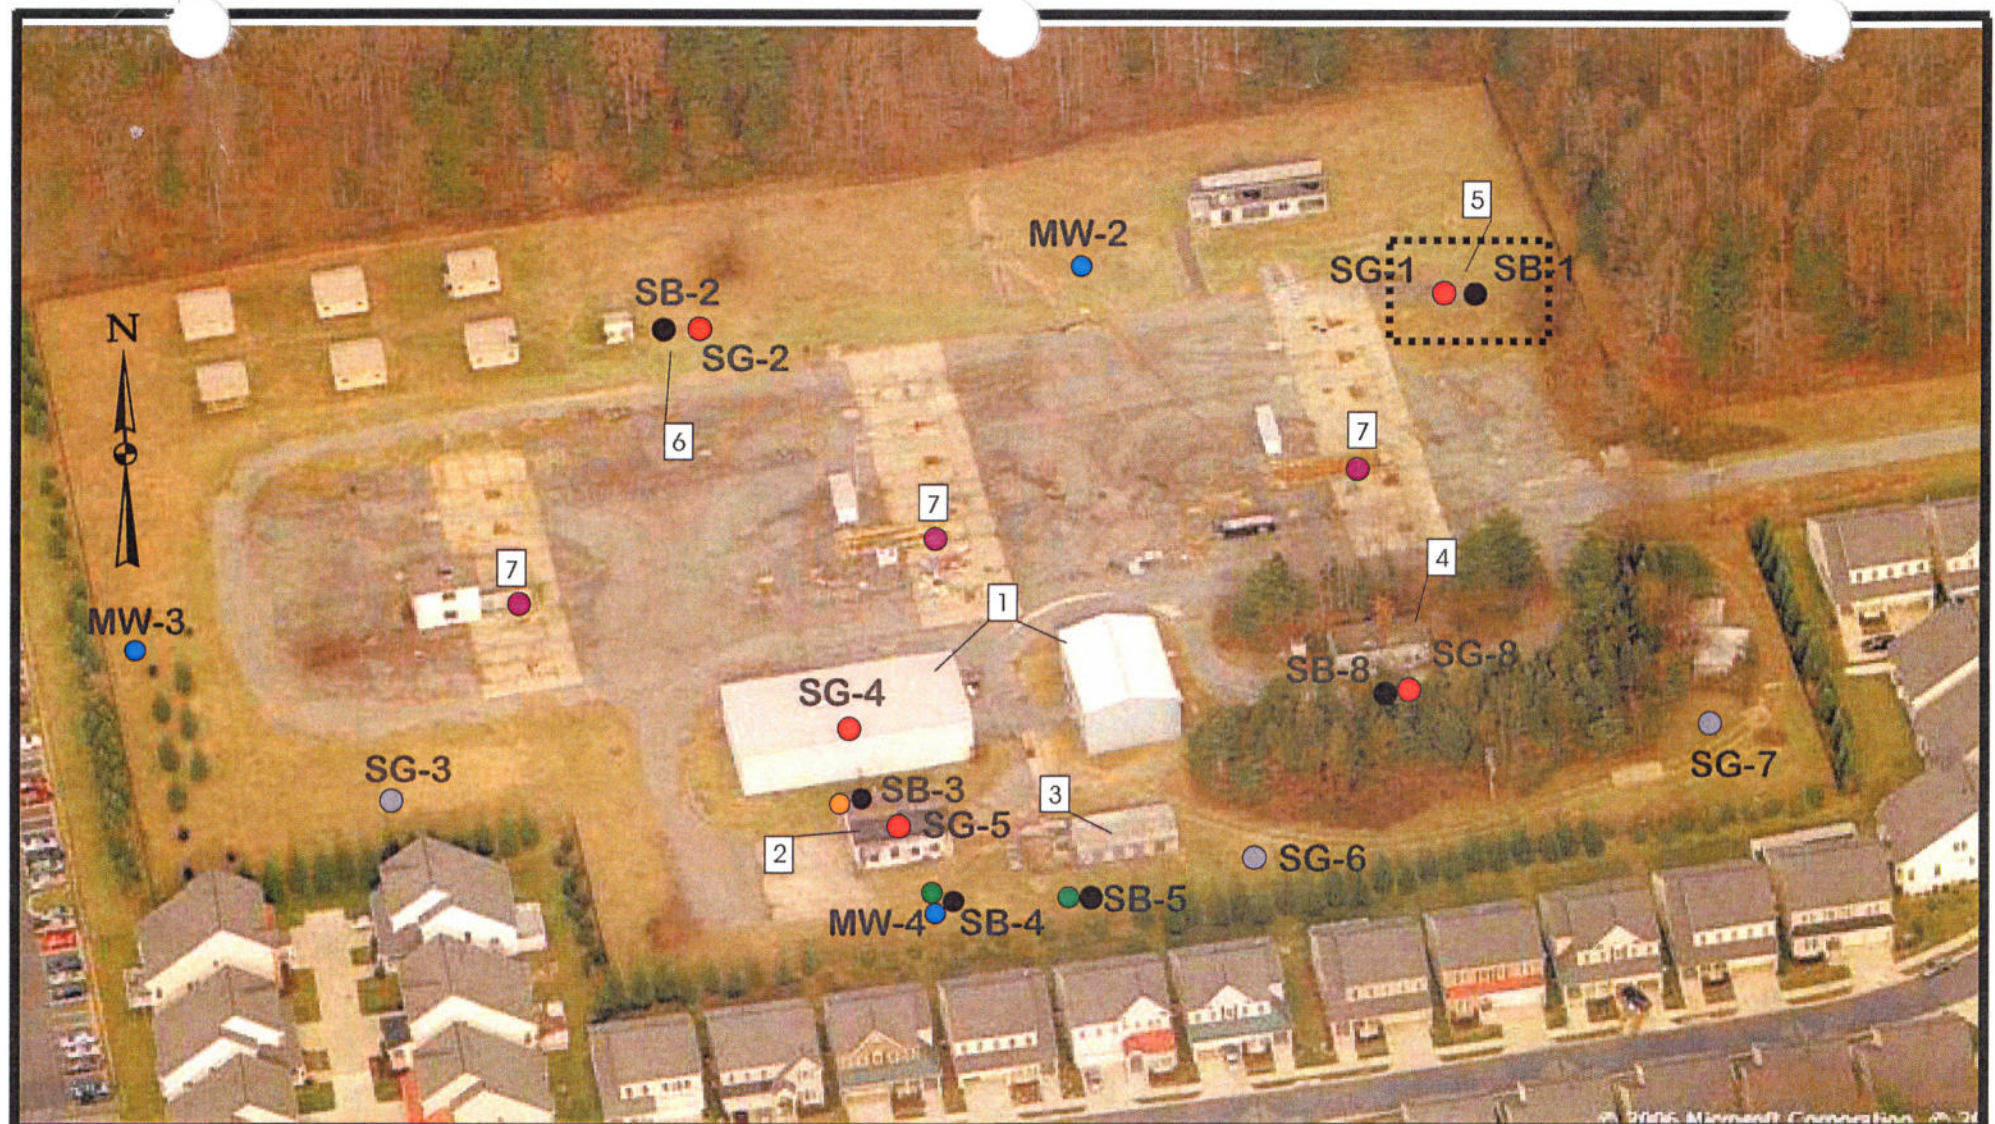
Areas of Concern

- 1) Storage Buildings
- 2) Machine Shop / Former Missile Assembly
- 3) Sub-Station / Former Generator building
- 4) Propellant Handling Building
- 5) Former Burn Tower
- 6) Previous sample location D-3
- 7) Missile Silos

Based on existing information, Areas of Concern (AOC) have been identified on the site (Figures 2 and 3). In accordance with our MDE-approved Work Plan dated August 2007, ARM has investigated each AOC to identify impacts to the surface and subsurface soils, and determine if any may present a continuing source of groundwater contamination through the collection of shallow soil samples, and both shallow soil gas and sub-slab soil gas samples. Additionally, ARM has re-sampled the three existing groundwater monitoring wells

Identified as SB-2 on Figure 2, a previously identified AOC that required additional investigation is historical soil sample location D-3 in the northwestern portion of the Site. This AOC was investigated to identify impacts to the surface and subsurface soils. ARM advanced

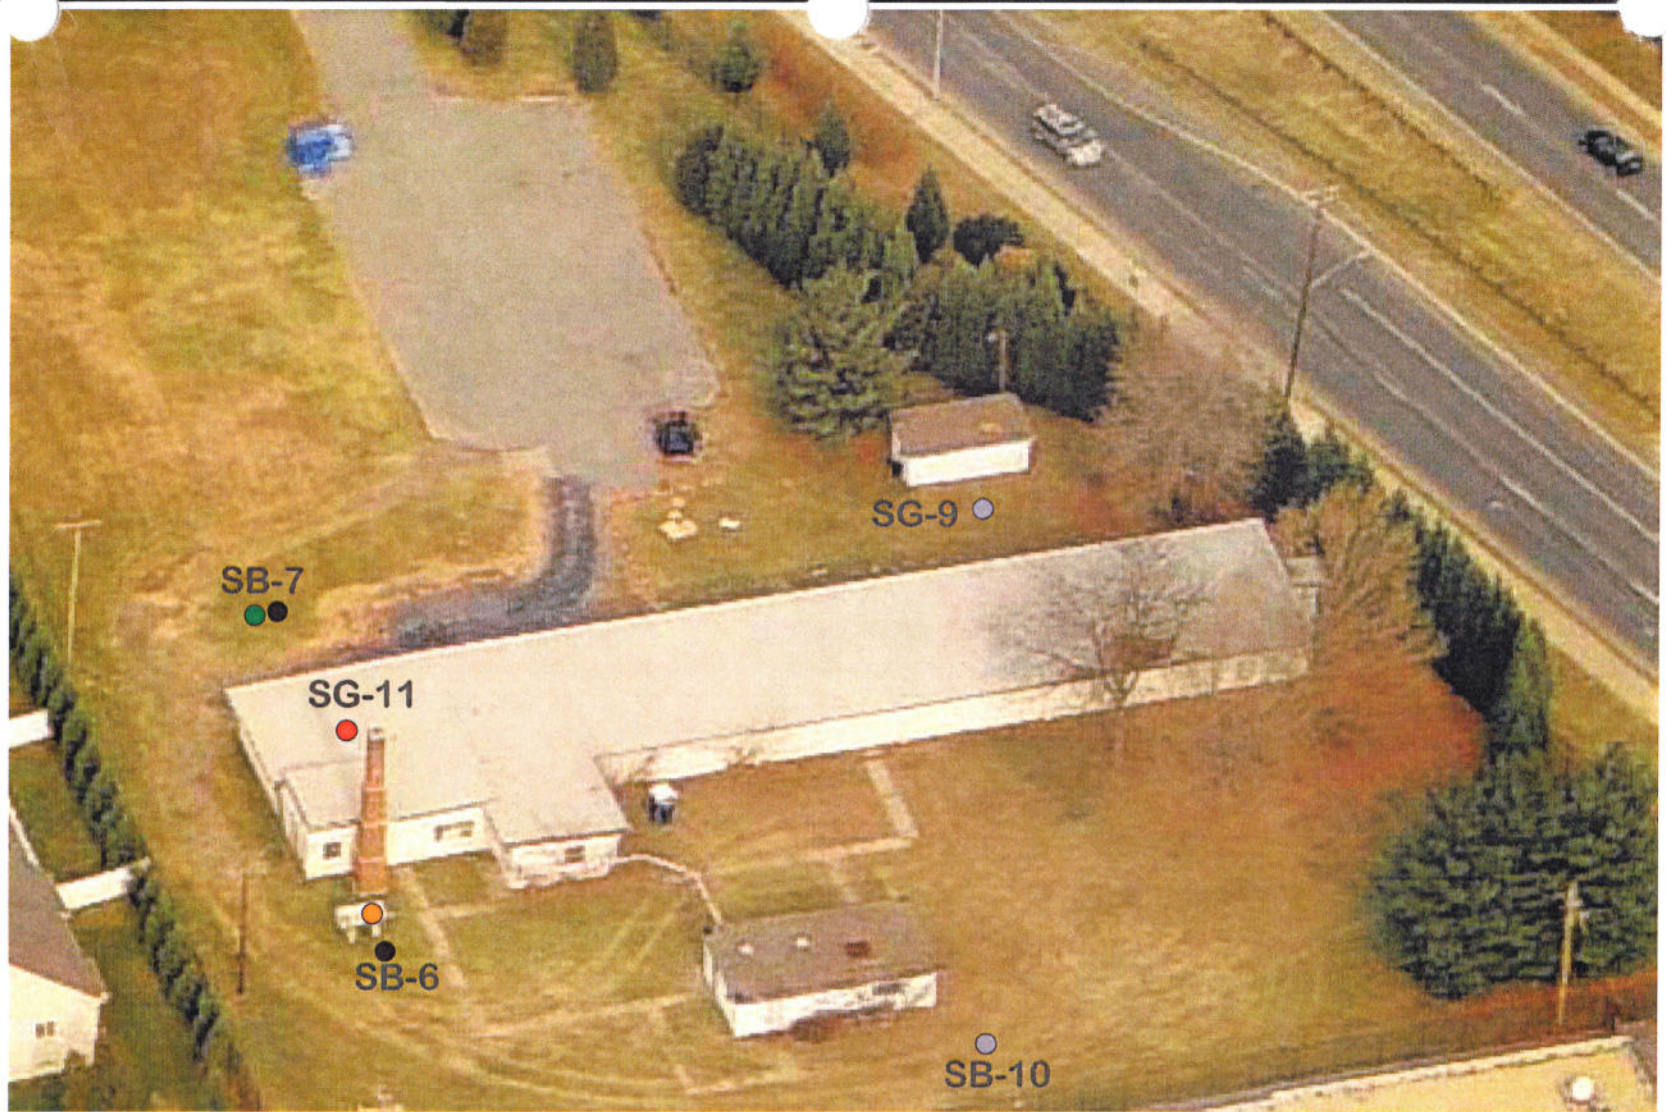
Figure 3

- Location of AST
- Location of Former UST
- Soil Sample
- Sub-Slab Soil Gas Sample
- Deep Soil Gas Sample

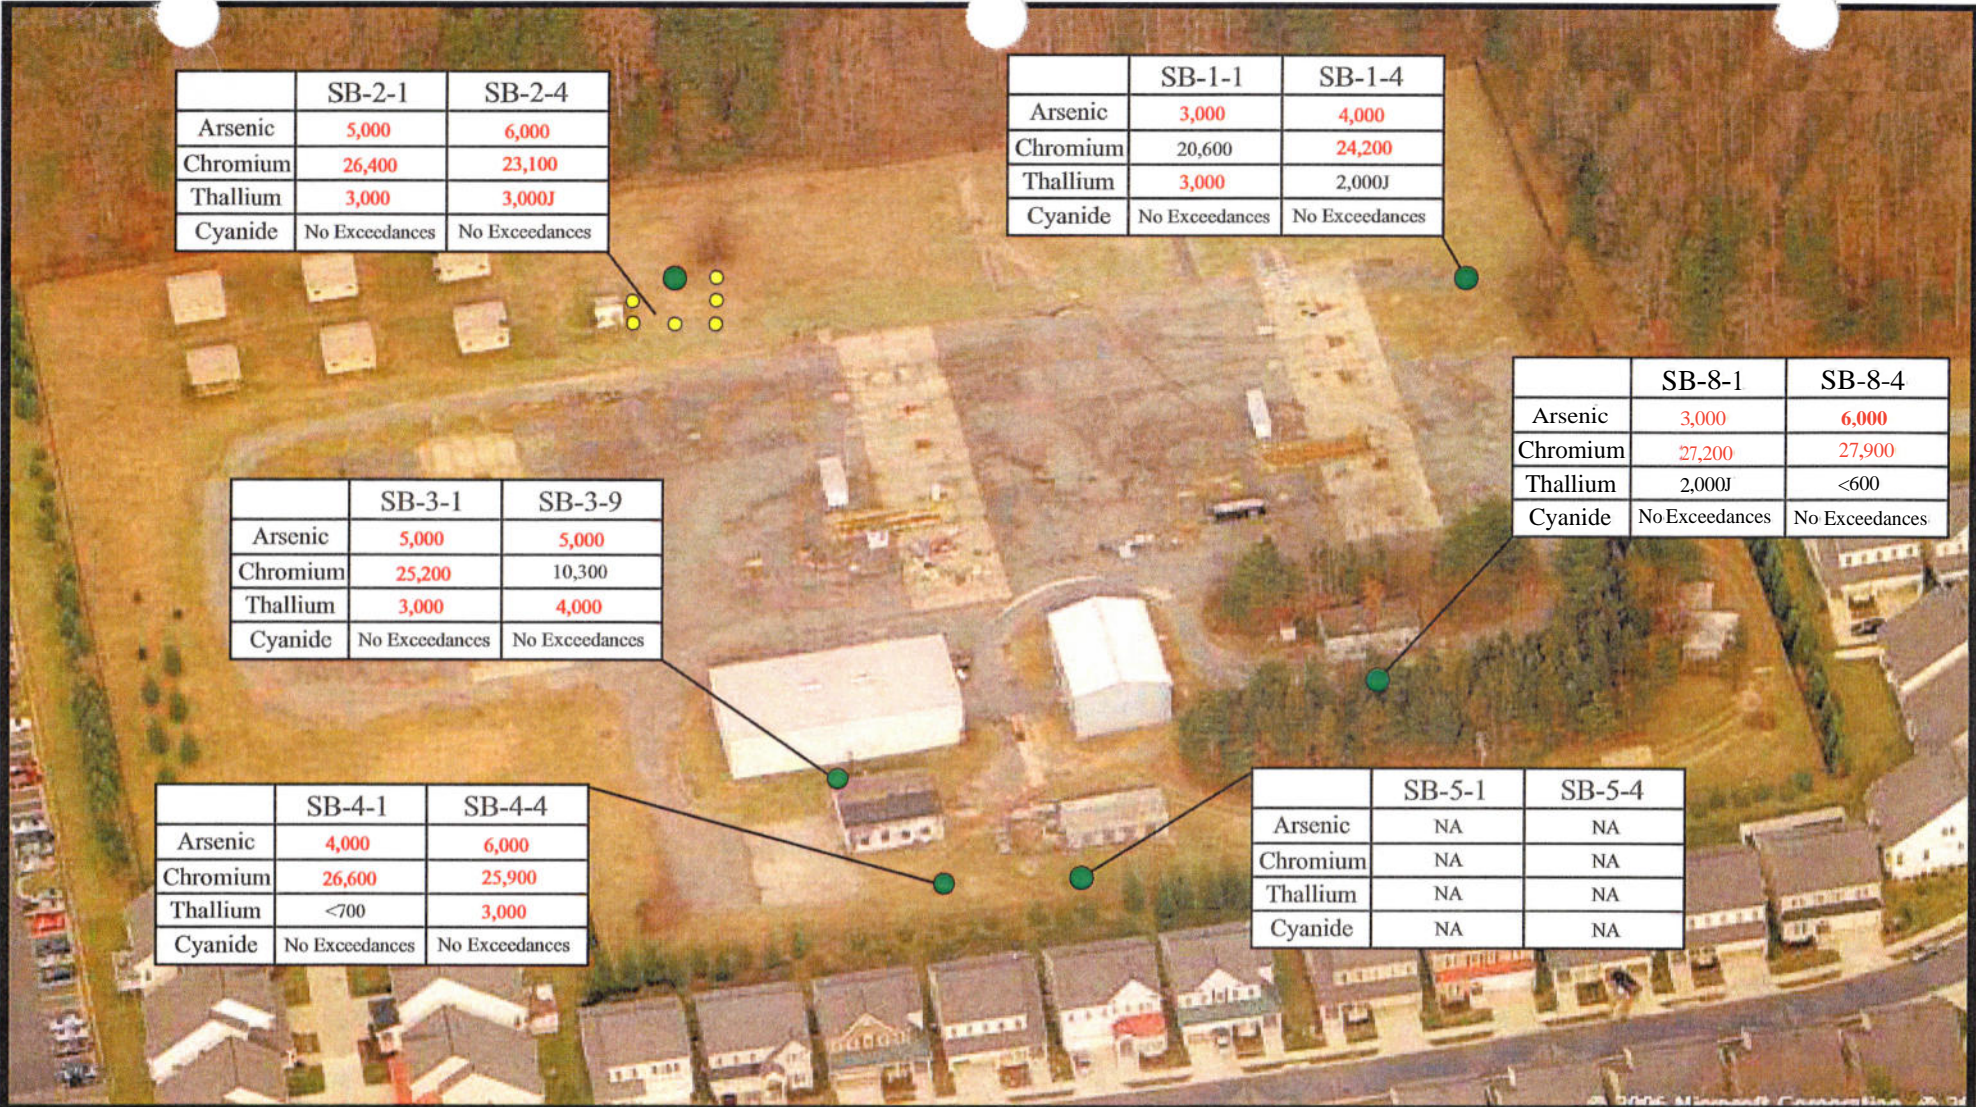
● Soil Sample Location
○ Shallow Soil Boring Location for Screening
Soil Sample Results in ug/kg
NA indicates sample not run for these parameters
Results provided for only those compounds with at least one exceedance of a MDE Clean-Up Standard
Values in Red Indicate an Exceedance of the MDE Residential Clean-up Standard for Soil

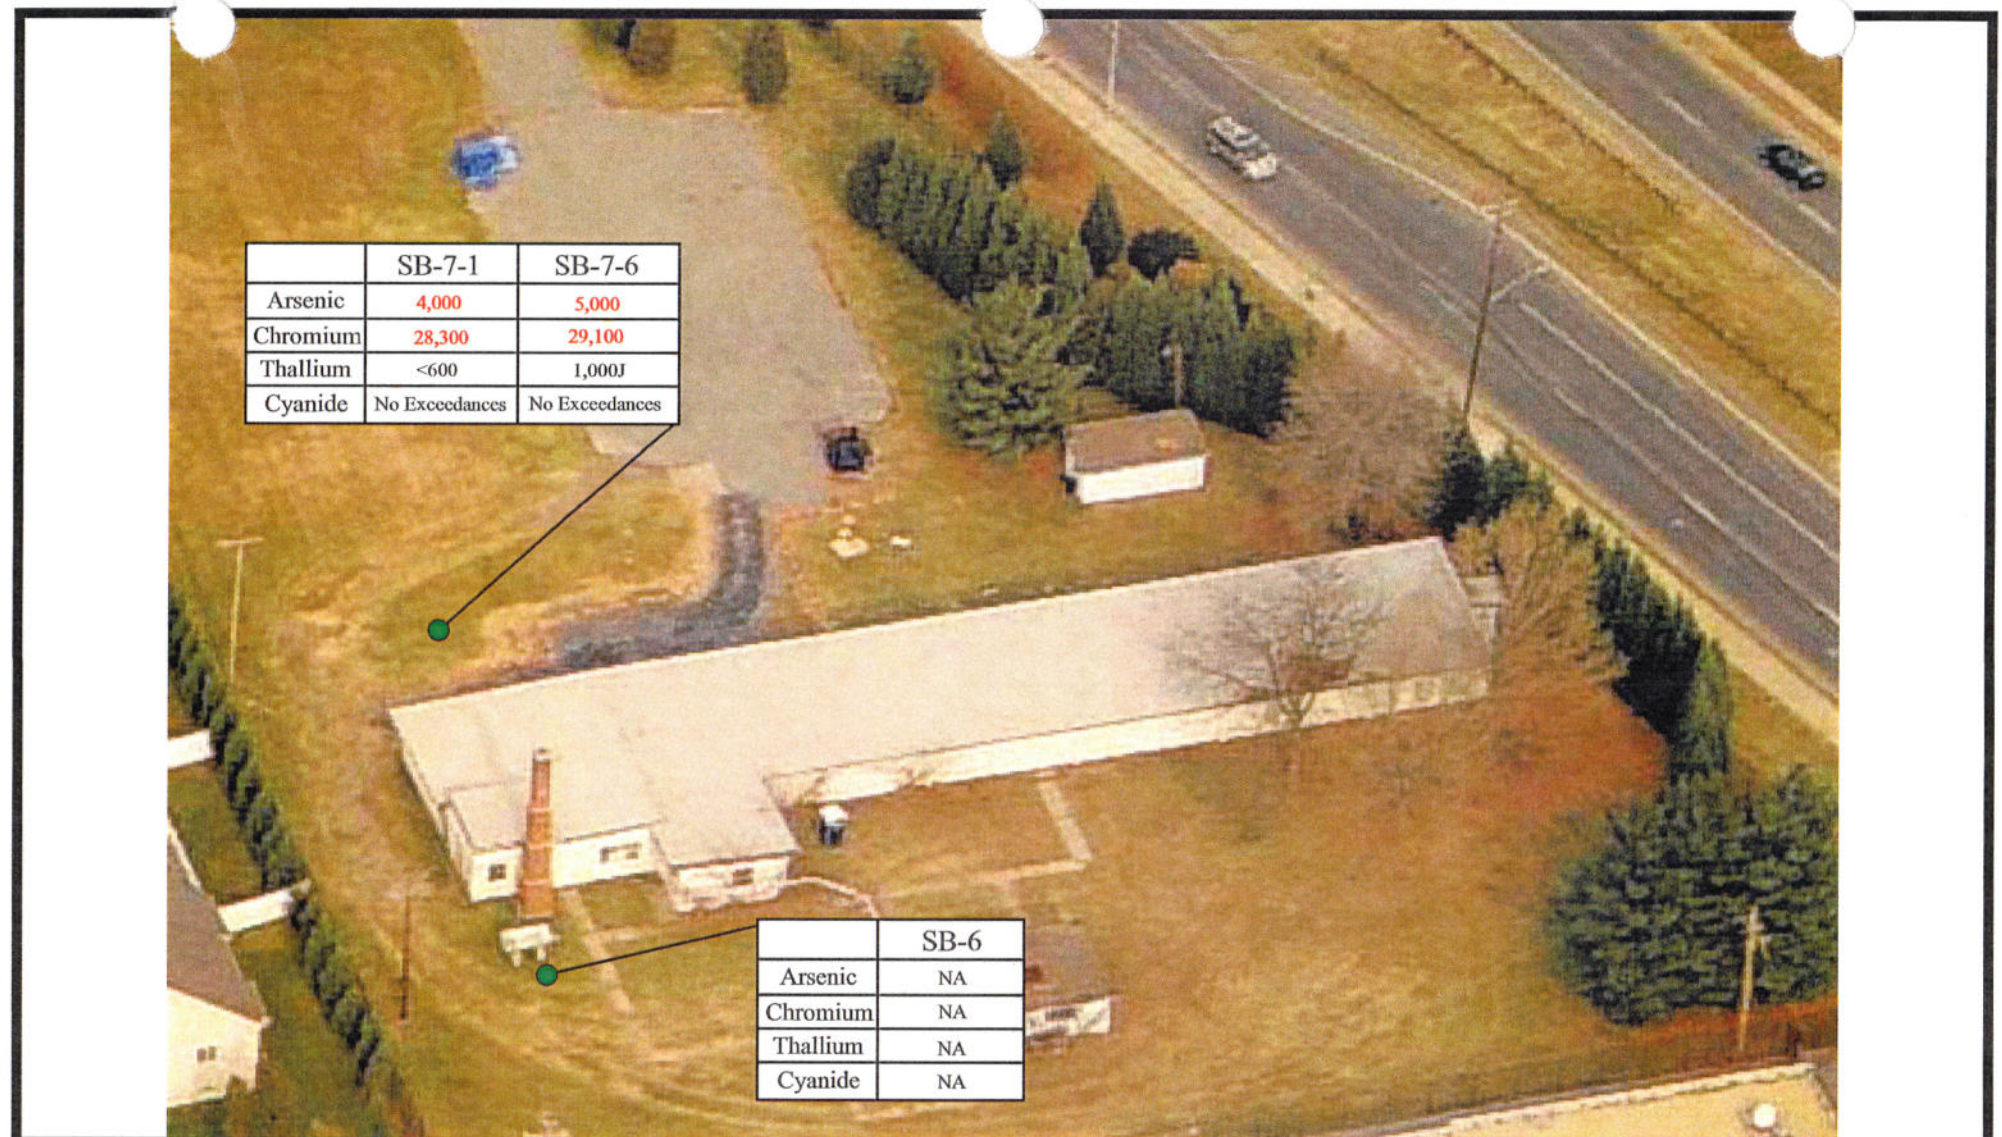
● Soil Sample Location

Soil Sample Results in ug/kg

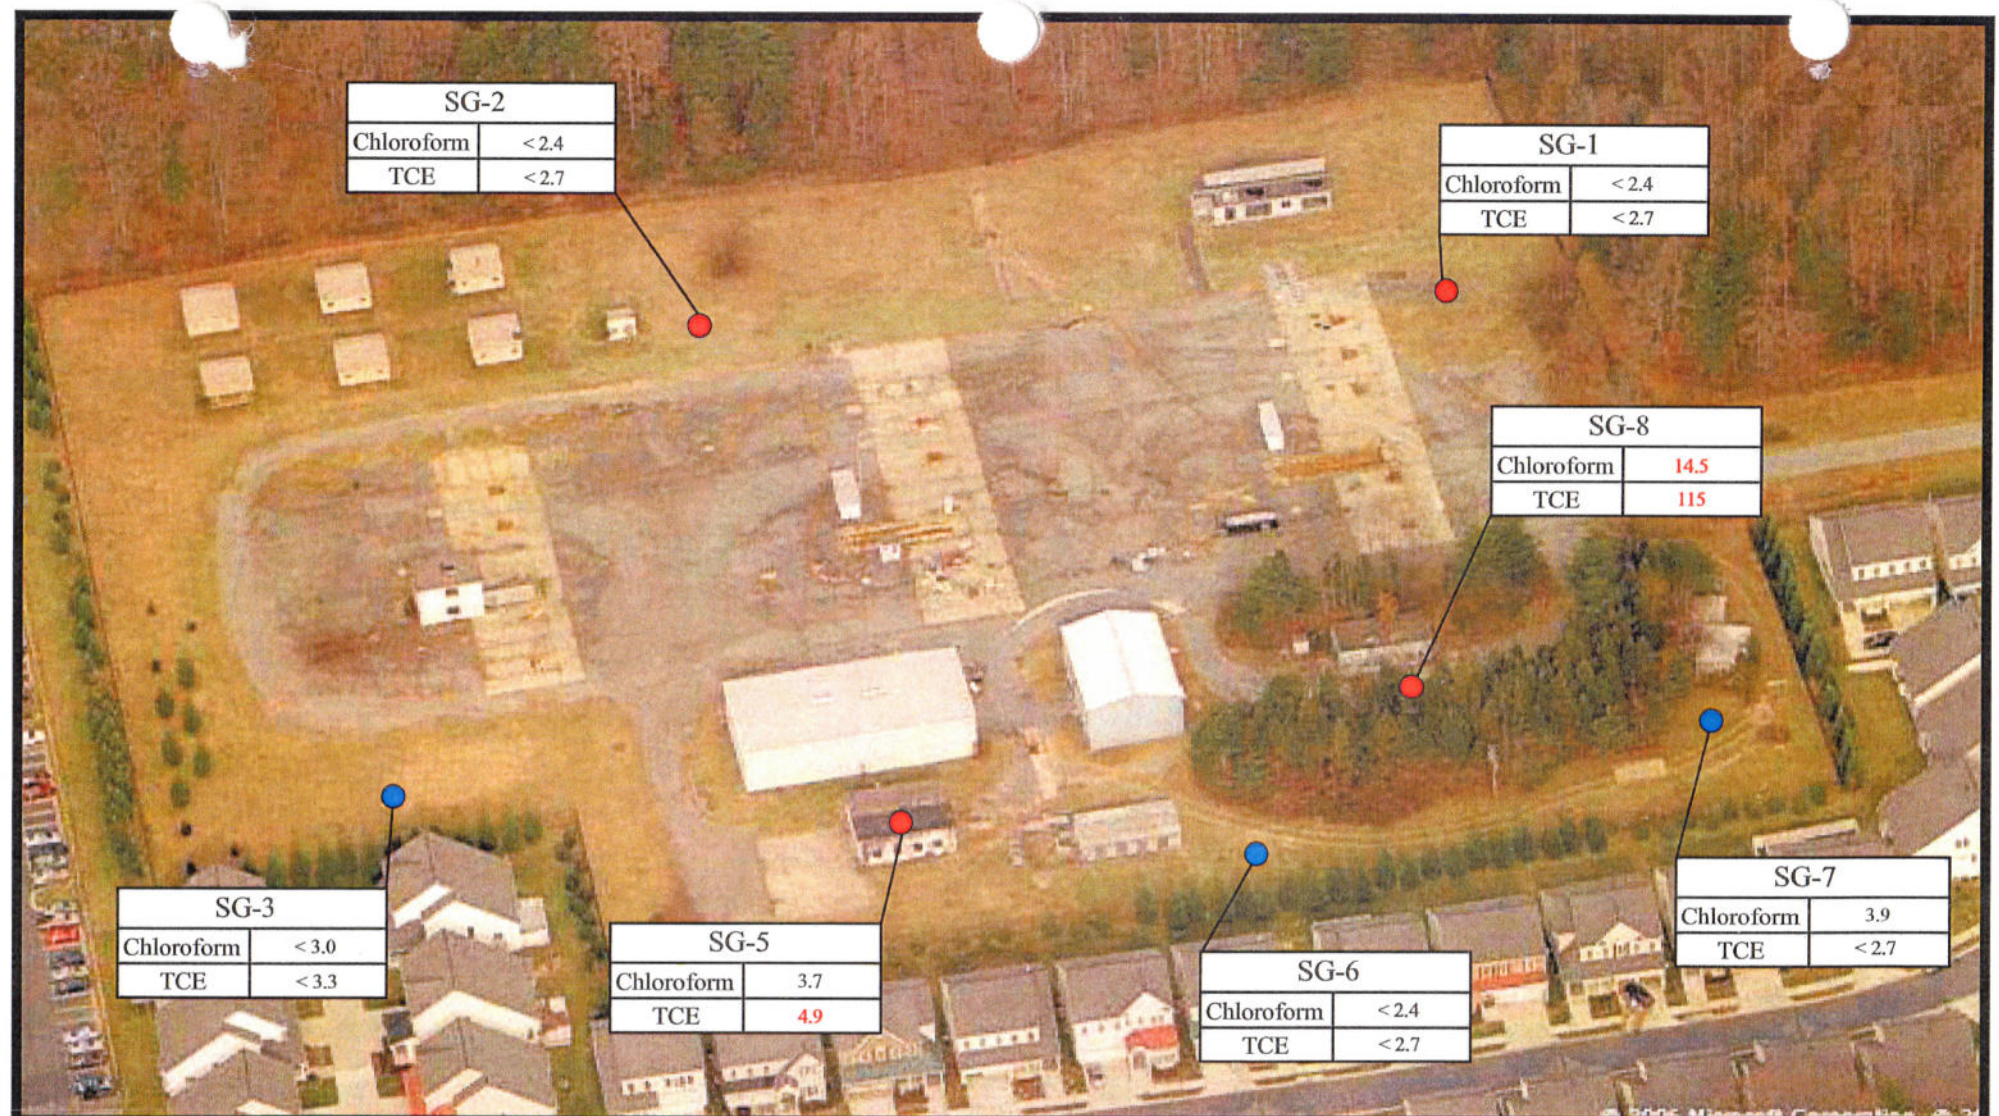
● Shallow (4' bgs) or Sub-Slab Soil Gas Sample

● Deep (10' bgs) Soil Gas Samples

Based on the observed concentrations in the soil gas samples, the accumulated vapors beneath the existing buildings and paved area could represent an unacceptable risk under the future recreational land use scenario via vapor intrusion to indoor air if the existing buildings are not demolished or if new buildings are constructed within the footprint of the potentially impacted areas where the elevated vapor concentrations were observed. It is ARM's recommendation that a sub-slab venting system be installed and operated if these existing buildings are to be used. If new buildings are constructed in the same location, a vapor barrier beneath the new building should be incorporated into the construction.

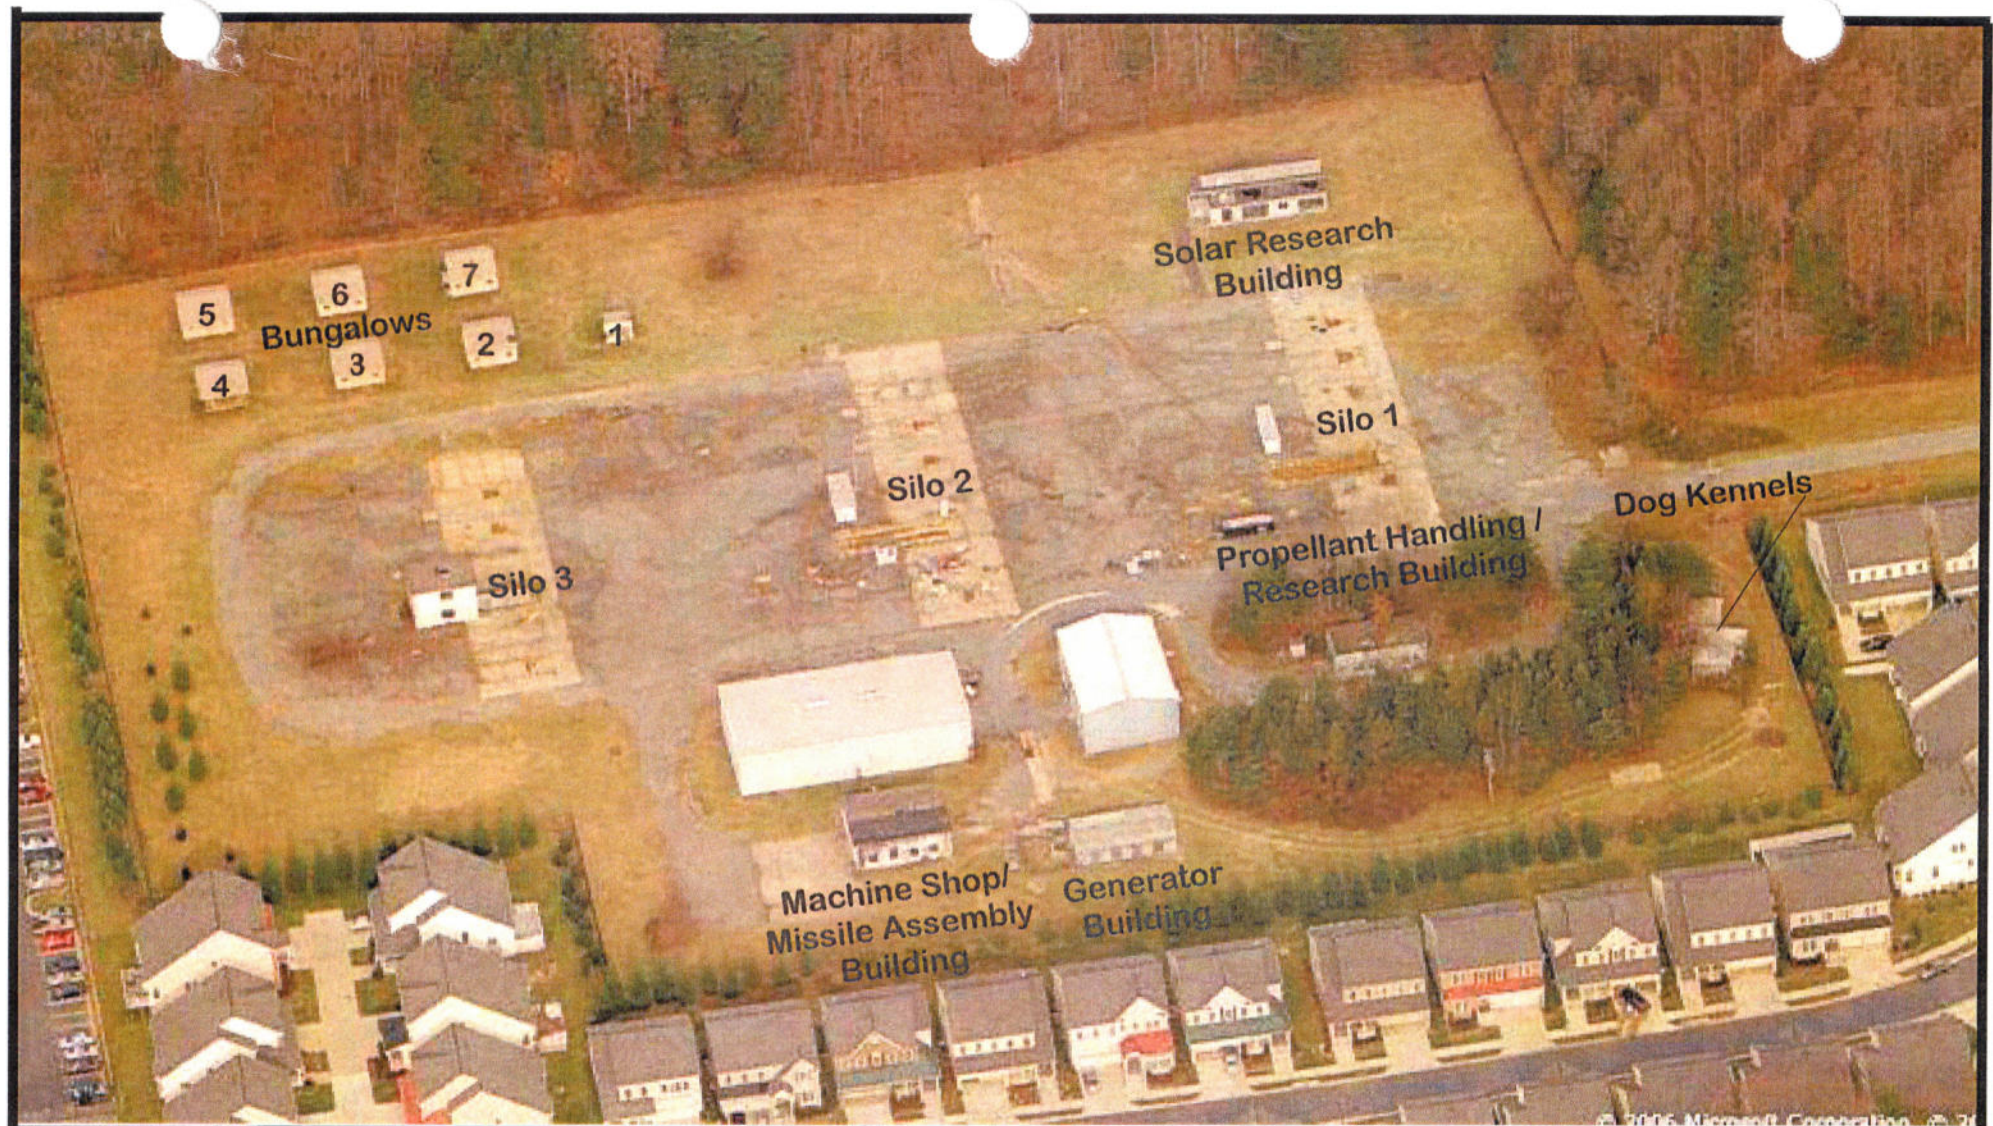
Figure 11

Fungal (mold) growth was observed on the ceiling of Bungalows 2 and 4, and throughout the Missile Assembly Building (**Figure 11 and Figure 12**). Water damaged materials were observed in the kennels, the small building to the rear of the barracks, and the generator building. The mold conditions should be corrected if any of these buildings are expected to be occupied. These materials are not subject to special handling or disposal requirements if the buildings are to be razed. However, contractors completing the demolition activities should be made aware of the potential presence of mold within these buildings.

- Fungal (mold) growth was observed on the ceiling of Bungalows 2 and 4, and throughout the Missile Assembly Building. Water damaged materials were observed in the kennels, the small building to the rear of the barracks, and the generator building. These materials are not subject to special handling or disposal requirements if the buildings are to be razed. However, contractors completing the demolition activities should be made aware of the potential presence of mold within these buildings.
